REPORT NO. NASA CR-132380

**EVALUATION OF A METAL FUSELAGE PANEL'S  
SELECTIVELY REINFORCED WITH FILAMENTARY  
COMPOSITES FOR SPACE SHUTTLE APPLICATION**

**FINAL REPORT**

CONVAIR DIVISION OF GENERAL DYNAMICS  
San Diego, California

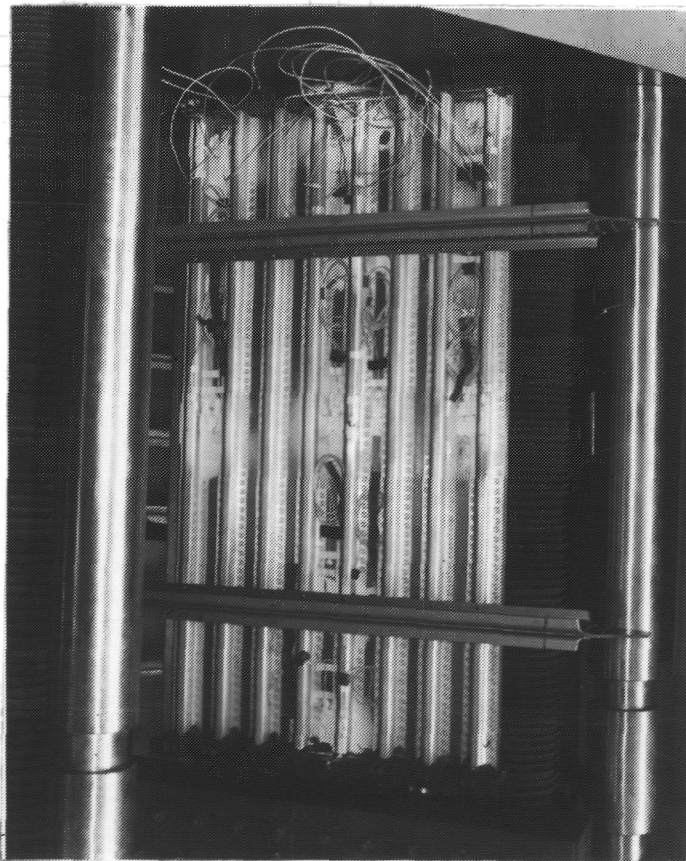
Figure 10.2. Compression panel in Test Machine. 139
